Bureau Enquêtes-Accidents

REPORT

*on the accident on 12 November 1999
North of Pristina (Kosovo)
to the ATR 42-300 registered F-OHFV
operated by SI FLY*

F-FV99112A

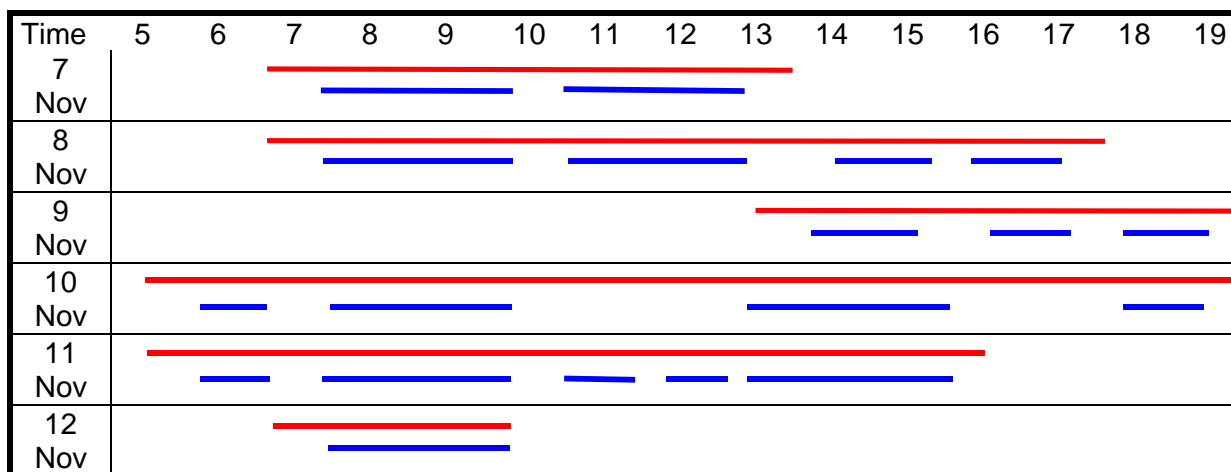
Figure 2 : Captain's activity in the week preceding the accident

Since the 1st of November, the Captain had flown fifty-two hours. He had had two non-flying days, on the 4th when he was available for the Director of flight operations, and the 6th when he had a rest day. Between the 7th and the day of the accident, he had flown thirty-two hours. The day before the accident, he had ferried from Ancona to Rome beginning his duty period at 5 h 45. His day continued with the Rome-Pristina-Tirana-Pristina-Rome line.

On the day of the accident, he went on duty at the Rome Ciampino airport, situated at around 20 minutes from his home. The arrival normal time before takeoff for a scheduled flight is 45 minutes.

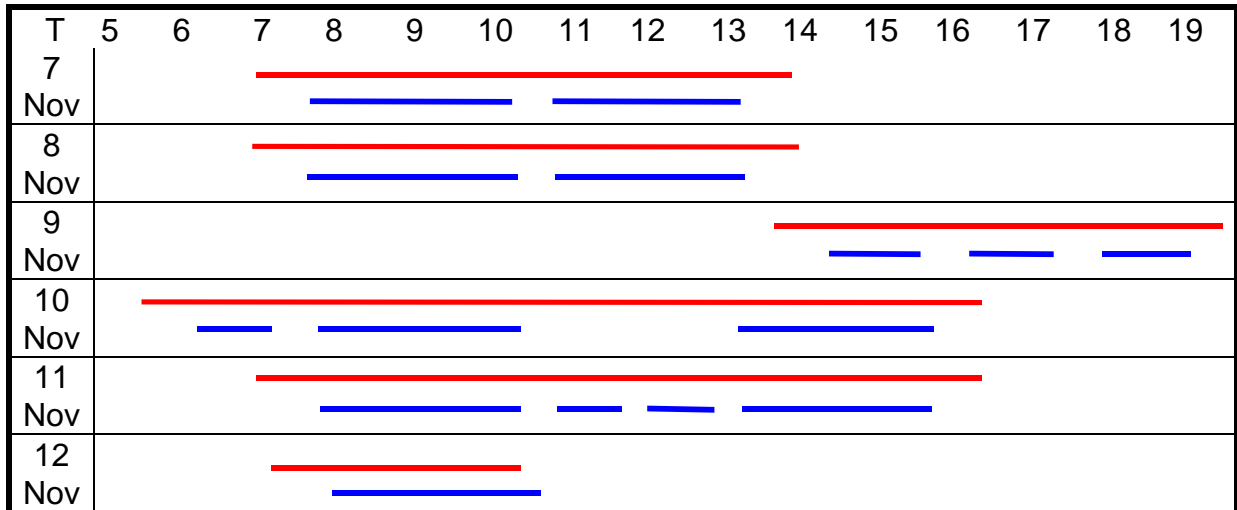
Figure 3 : Copilot's activity in the week preceding the accident

Since the beginning of November, he had flown forty-three hours. He had had two non-flying days, on the 4th when he was available for the Director of flight operations, and the 6th when he had a rest day. Between the 7th and the 12th, he had flown 27 h 30 min. The day before the accident, he had done the Rome-Pristina-Tirana-Pristina-Rome route with the same Captain.

On the day of the accident, he went on duty at Rome Ciampino airport, situated at around 15 kilometres from his home, for an eight o'clock takeoff.

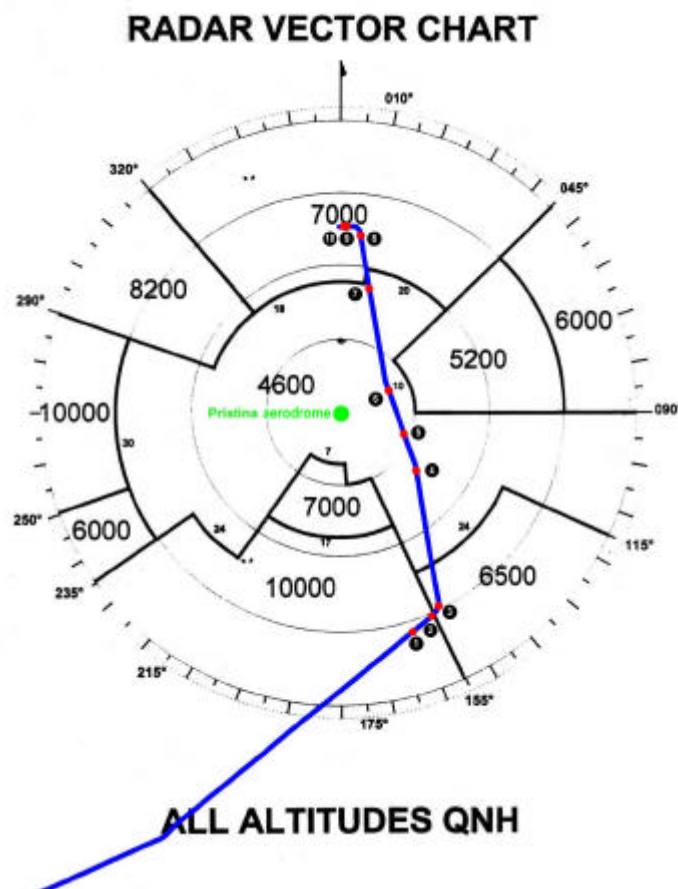
Figure 9 : Radar Data

At the time of the accident, a French Air Force AWACS was on a mission in the region. Information relevant to the tracks of KSV 3275 and HCN 993 was provided to the investigators. It showed an approximate speed of 250 kt for KSV 3275 and of 400 kt for HCN 993. It allowed them to validate the track calculated from the parameters recorded on the aircraft's Flight Data Recorder (see 1.11.3) and to determine the relative position of the two aircraft at the moment when HCV 993 became number one for landing (see § 2.2).

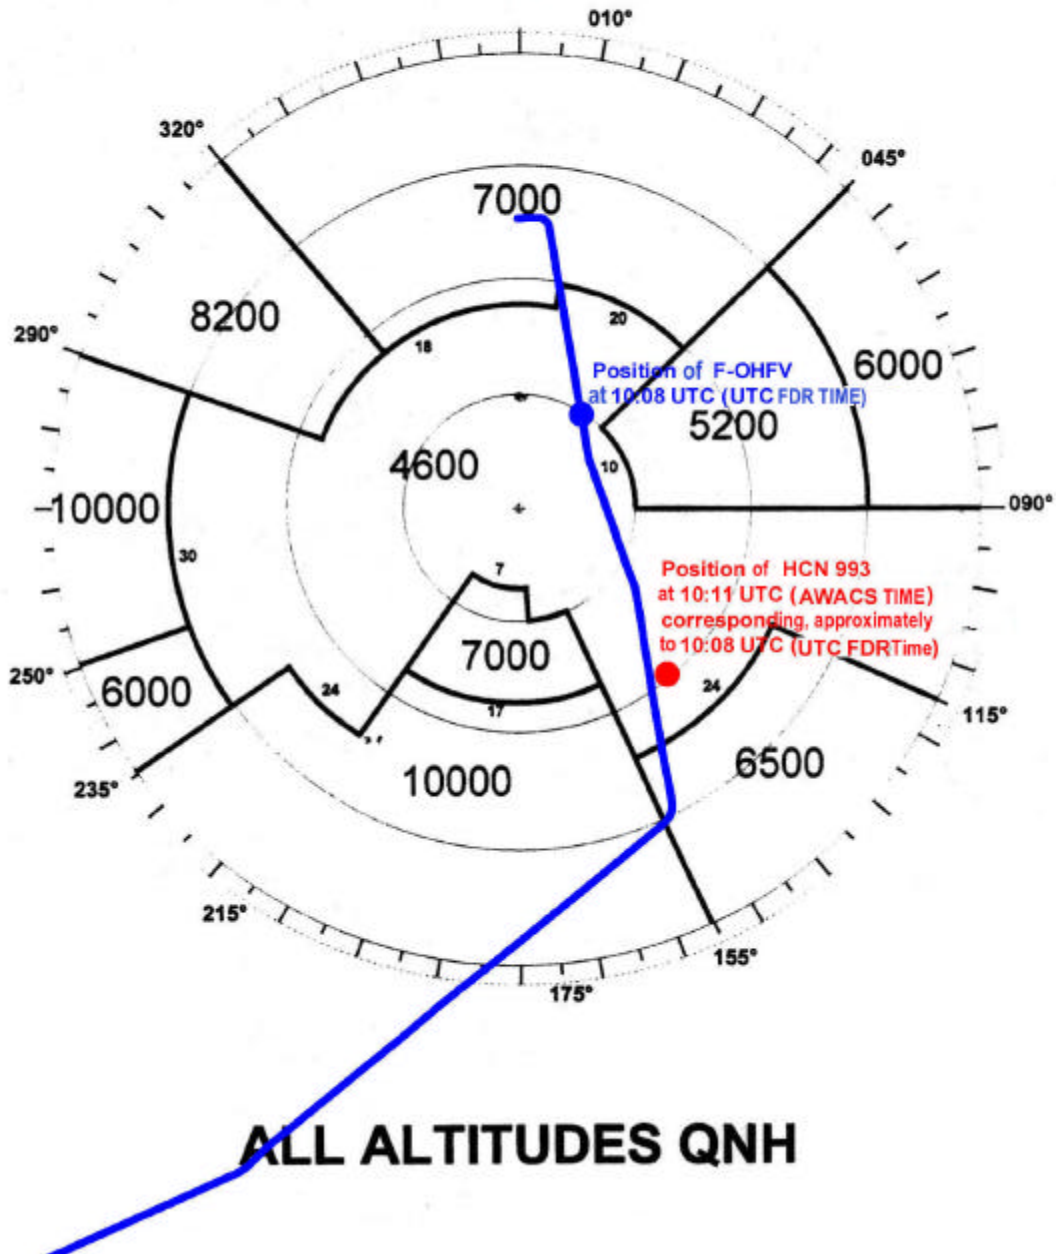
Figure 18 : Relative position of aircraft F-OHFV and HCN 993 when HCN 993 took number one position for landing

Position of **F-OHFV** and **HCN 993** at 10:08 UTC

These relative positions must be viewed with caution due to the low sample rate of data related to HCN 993, and to the difference of around 3 minutes between the UTC time on F-OHFV's FDR and that of the AWACS which recorded the track of HCN 993

After announcing the type of service provided, RIS in this case, the controller gave headings and altitudes to flight KSV 3725 which were in accordance with the minimum radar safety altitudes in the sector to vector it towards the ILS interception point. However, having changed its position to number two for approach, he had to extend its track away to the north a little more than he had planned, which took the aircraft into an area where the radar minimum safety altitude went up from 4,600 to 7,000 feet. This manoeuvre probably led to the loss or clutter of the ATR's radar signal, because of poor detection in this mountainous region. This
